Service report

Separator

Major Service

WSPX 407TGD-71CG

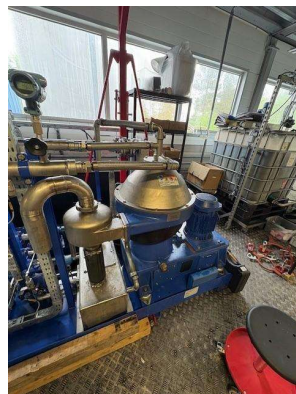
Picture of separator.

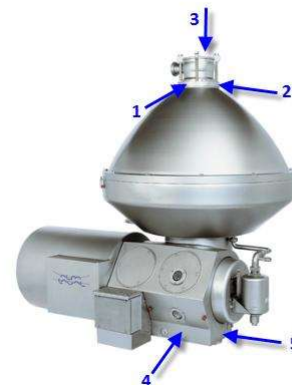
Point	Measurement before	Measurement after	Unit
1	Value	3,0	mm/sec.
2	Value	2,0	mm/sec.
3	Value	1,9	mm/sec.
4	Value	2,1	mm/sec.
5	Value	1,8	mm/sec.
Bowl speed	Value	8375	Rpm.
Product	Empty: <input type="checkbox"/> Water: <input type="checkbox"/> Product: <input checked="" type="checkbox"/>		
Flow	Value	?	m ³ /h
